08/26/2005

Re: Site address
City, CO 80020

Report Summary

Abacus Inspection Service
3250 Darley Avenue
Boulder, CO 80305
303-554-5840
AbacusInspection.com

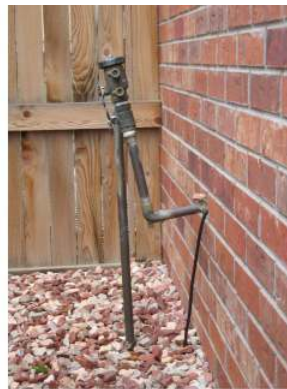
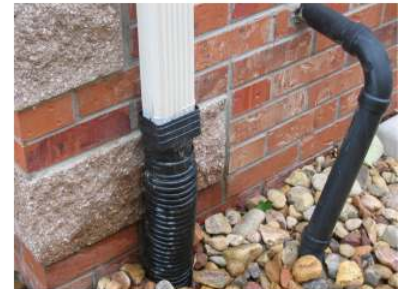
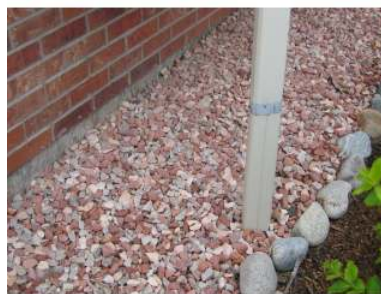
GRADING:

SITE: Soil is settling on W side of home pulling sprinkler piping down. This is causing strain on the piping shown in the photo. Have a licensed plumber relieve strain on pipes. Settling can also be seen at the gutter downspouts.

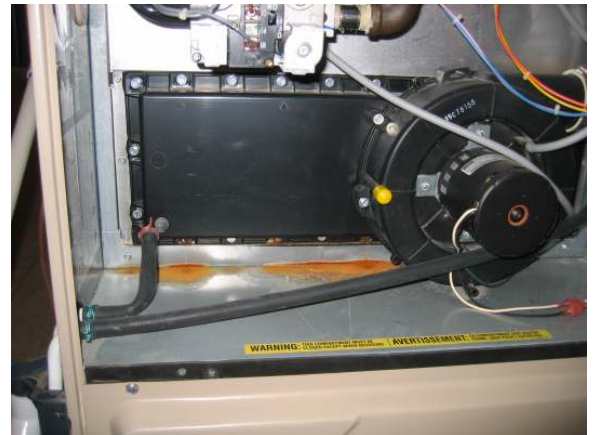
PRIMARY UNIT:	Rust is noted under the top cover, and signals a problem. I recommend this unit be evaluated by a licensed HVAC contractor.
----------------------	---
